Flying the Lockheed SR-71 - RAF Mildenhall to Murmansk
Col. Richard Graham (USAF Retd)
15 March 2016

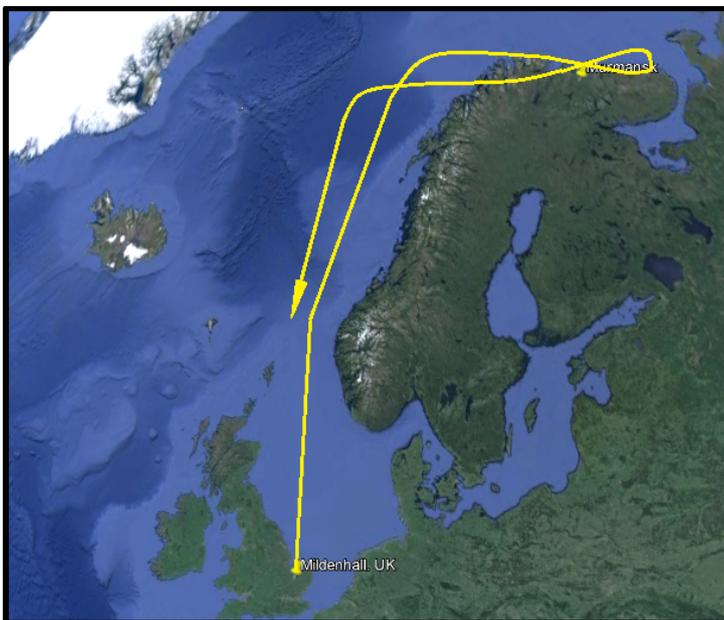
The SR71 mission profile was not precisely detailed, but this is roughly the route described from Mildenhall to Murmansk. once overflown, the aircraft turned to overfly the 'target' again in the opposite direction, and then navigated back to base over the North Sea. Total distance covered would have been in excess of 3,300n.m.

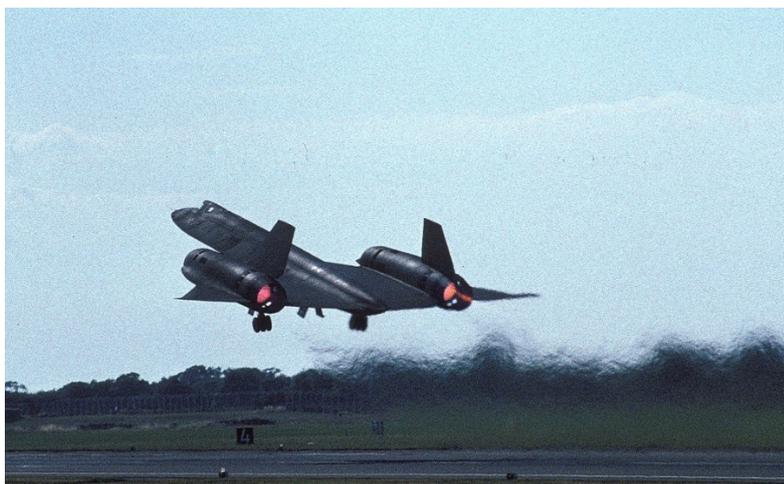
Take-off rotation occurred at 180kts, and lift-off at 210kts. The aircraft accelerated to 400kts, and reached 25,000ft altitude after two minutes. The aircraft was allocated airspace and had no need to request routeings on the radio. It received the highest priority.

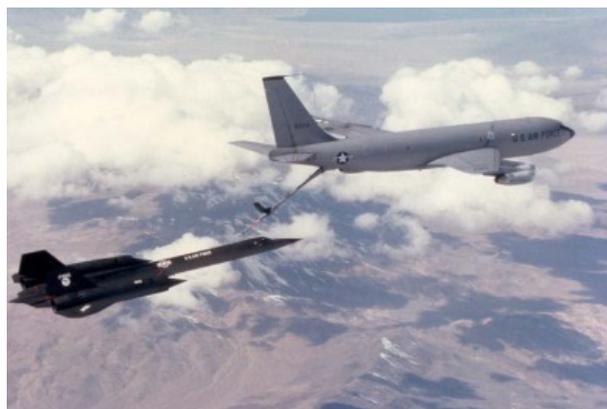
The pilot flew the SR-71 to hold station below and aft of the boom operator's position and the refuelling boom was flown into the aircraft's refuelling receptacle.

The aircraft used high-energy fuel (JP7) and had a team of dedicated tankers which used this fuel exclusively. Over some 15-20 minutes around 80,000lb (36,300kg) of fuel was transferred from the tanker.

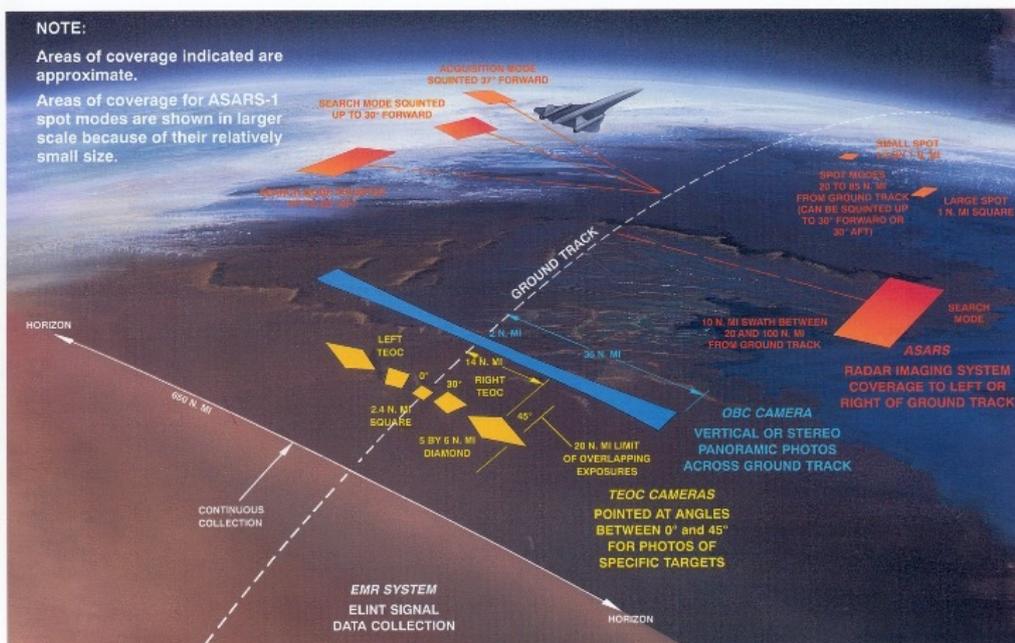
Sensor Data Collection (Terrain Coverage at 80,000 Feet)

This sensor diagram was used in the presentation to illustrate the kinds of devices used, and over what distances they could gather information.

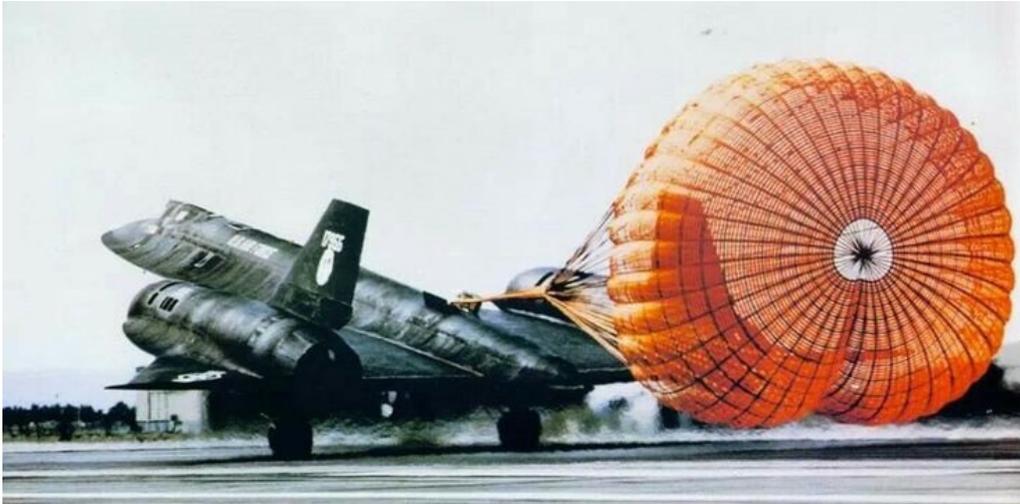
The aircraft used a drogue chute to decelerate and would turn off at the runway end, where the mobile crew was waiting to guide them along taxiways to the apron/ramp area so that the crew could shut-down the engines. Opening the cockpit and breathing fresh air was welcome, and especially a drink, as most crew were dehydrated. There would be a foot-of-ladder de-brief and the crew would have time to shed their flying gear before entering an intelligence de-brief: this would be 10-20 minutes normally, prolonged only if anything unexpected had occurred. The aircraft was towed into the hangar and maintenance crews could, if necessary, have the aircraft ready for an equivalent mission within 24 hours.
